E-Unit Installation Damage

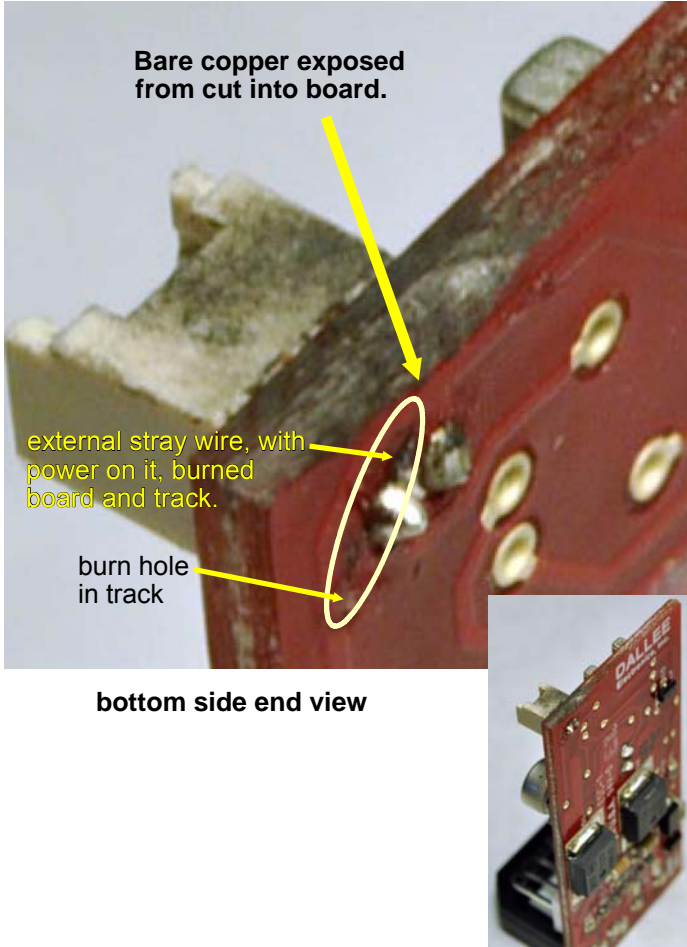
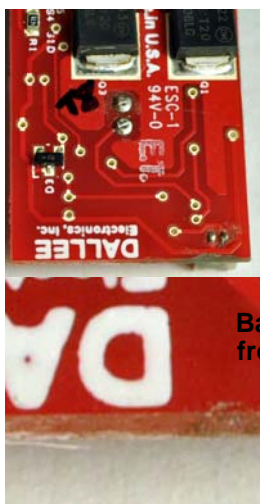
Don't let this be you. These pictures were made to show how items that get returned to us for "warranty repair" look sometimes. Typically a standard letter accompanies the unit claiming that they received it this way. As can be seen in these pictures, that is not the case. Without a magnifying glass, a quick look at the board would make one think that it's just fine and only a bit of grease became smudged on it. This board has two bad locations on it. Looking at the end view, there was apparently a flywheel or other item rubbing the board. It actually rubbed the glass epoxy pc board hard enough to make contact with the track on the board. There is bare copper exposed on the edge of the board which means that an improper electrical connection was made between the flywheel and the board. The other location appears as though a wire had also glanced the bottom of the board. This can be seen by the black line on the board. At the end of the wire / black line, there is a hole burned into the track causing an improper electrical connection. These two problems caused the device failure and do not qualify for a warranty repair. This unit also had the factory installed 3M tape replaced with an inferior brand. There are many different properties in tape, some of which are not desirable for use with electronic devices. Over time, the tape can degrade and cause electrical problems as well. Proper replacement double-sided tape is to be used to prevent problems from the tape occurring. Extra proper double-sided tape, item #388, is available for replacement as well as other uses.
