# E-Unit Installation Damage

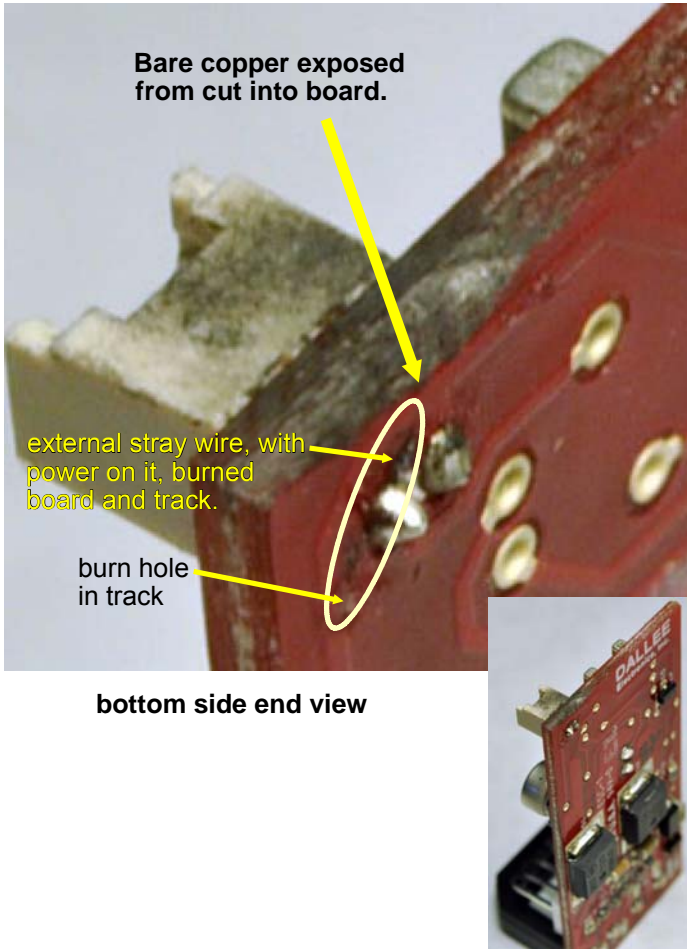
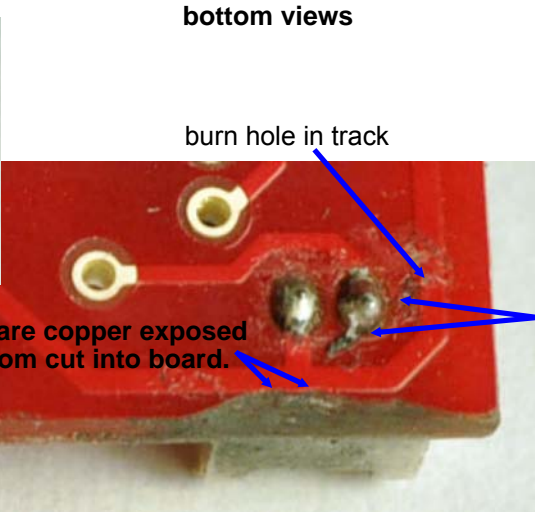
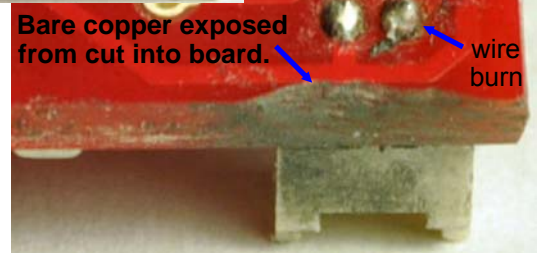
Don't let this be you. These pictures were made to show how items that get returned to us for "warranty repair" look sometimes. Typically a standard letter accompanies the unit claiming that they received it this way. As can be seen in these pictures, that is not the case. Without a magnifying glass, a quick look at the board would make one think that it's just fine and only a bit of grease became smudged on it. This board has two bad locations on it. Looking at the end view, there was apparently a flywheel or other item rubbing the board. It actually rubbed the glass epoxy pc board hard enough to make contact with the track on the board. There is bare copper exposed on the edge of the board which means that an improper electrical connection was made between the flywheel and the board. The other location appears as though a wire had also glanced the bottom of the board. This can be seen by the black line on the board. At the end of the wire / black line, there is a hole burned into the track causing an improper electrical connection. These two problems caused the device failure and do not qualify for a warranty repair. This unit also had the factory installed 3M tape replaced with an inferior brand. There are many different properties in tape, some of which are not desirable for use with electronic devices. Over time, the tape can degrade and cause electrical problems as well. Proper replacement double-sided tape is to be used to prevent problems from the tape occurring. Extra proper double-sided tape, item #388, is available for replacement as well as other uses.
